**National Highway
Traffic Safety
Administration**

ON-SITE AIR BAG INVESTIGATION

CASE NO. - 94-11
FLEET - RENTAL VEHICLE
LOCATION - [REDACTED] INDIANA
ACCIDENT DATE - [REDACTED] 1994

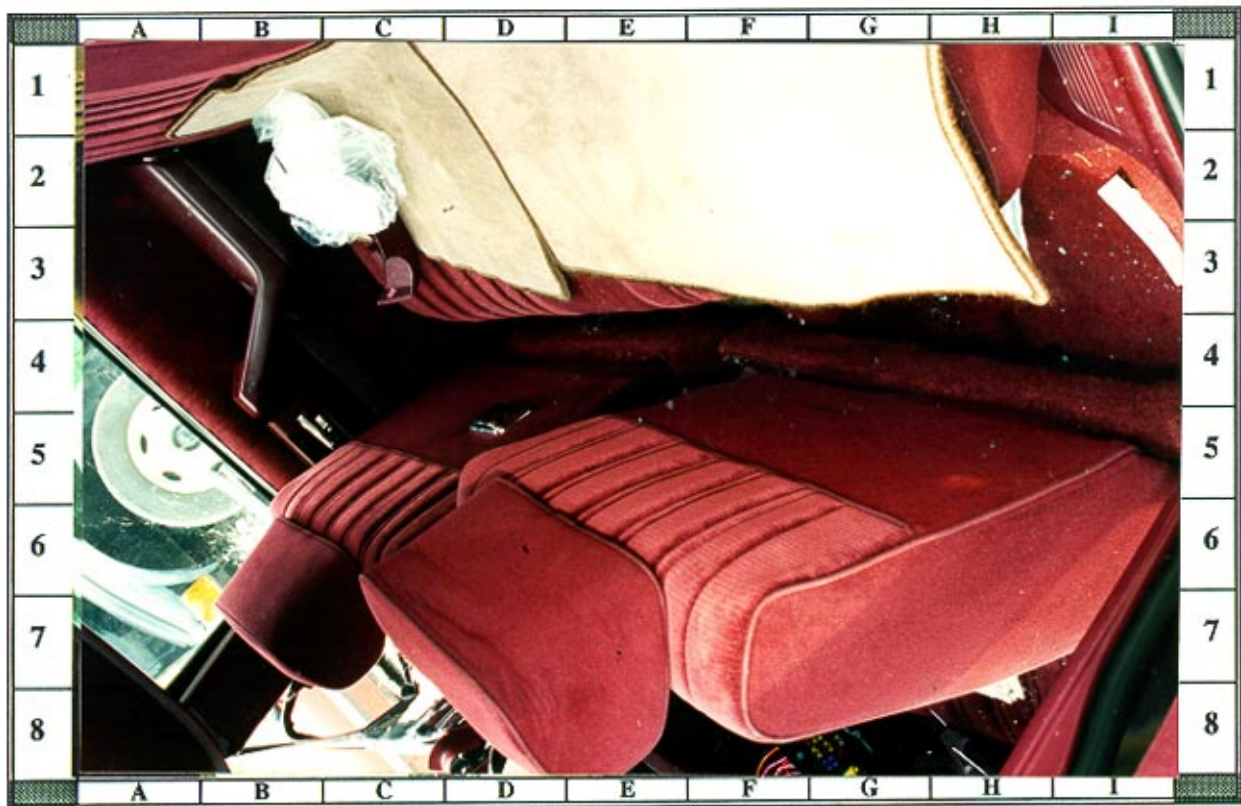
64 -- Rear passenger seating area & front seat backs of '94 Oldsmobile Cutlass; NOTE: RF seat intrusion into RR occupant's leg area
